Barton Creek Trail Work

Status Report: September 2022 - January 2023

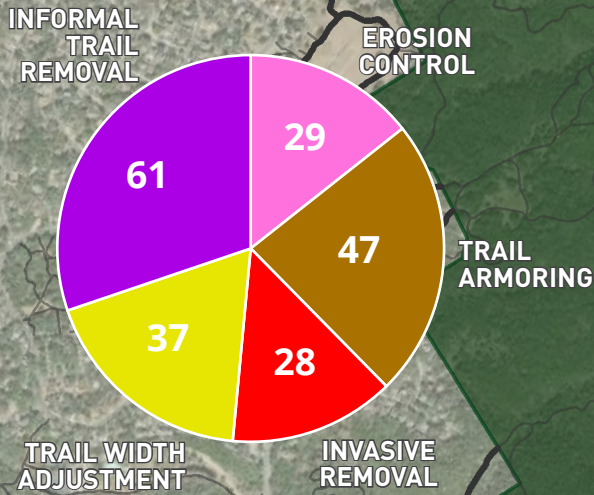
202 observations logged from SEPTEMBER 2022 TO JANUARY 2023

5 PROJECT TYPES

- ★ Two project types
- Erosion Control
- Trail Armoring
- Invasive Removal
- Trail Width Adjustment
- Informal Trail Removal
- Official Trail
- Unauthorized Trail
- COA Greenbelt

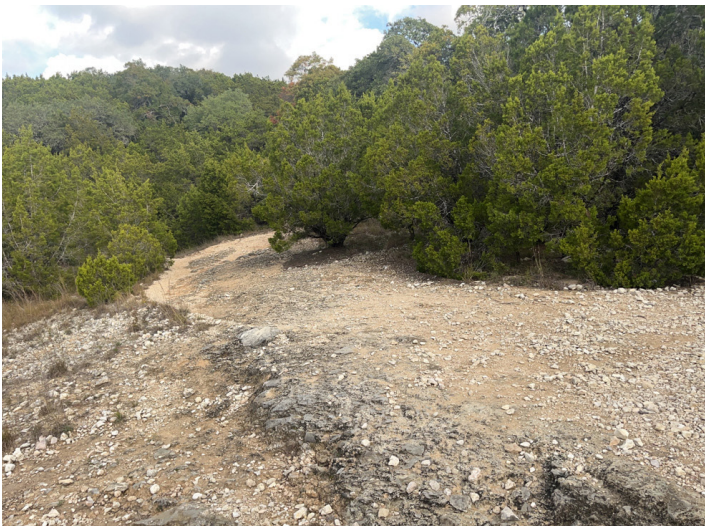
SHEET EROSION near Hill of Life Trailhead.

CAUSE	SOLUTION
SHEET EROSION	Infiltration is insufficient compared to intensity of rainfall	Decrease trail width, provide opportunities for water to be directed off trail
RILL EROSION	Runoff forms channels down a slope	Provide opportunities for water to be directed off trail. Seed natives
GULLY EROSION	Unresolved rill erosion leads to the formation of gully erosion	Provide opportunities for water to be directed off trail
BANK EROSION	Flooding and/or visitors utilizing informal water access points	Retire informal trails, build up support walls of rock and gravel, brush the area, and seed natives

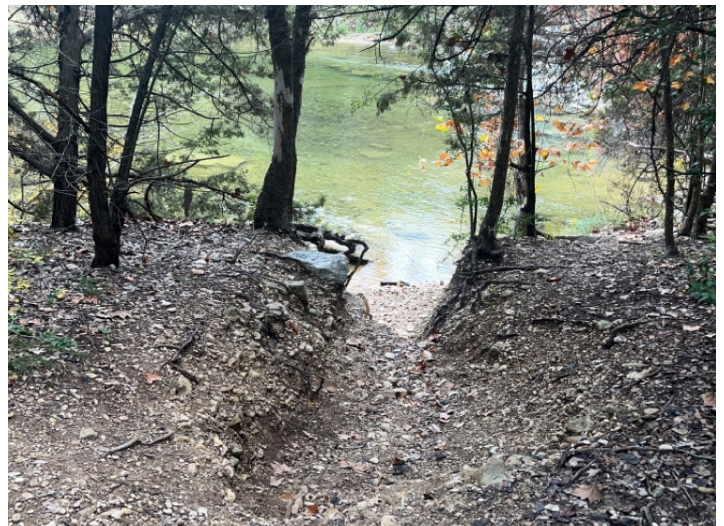
GULLY EROSION near Hill of Life Dam.

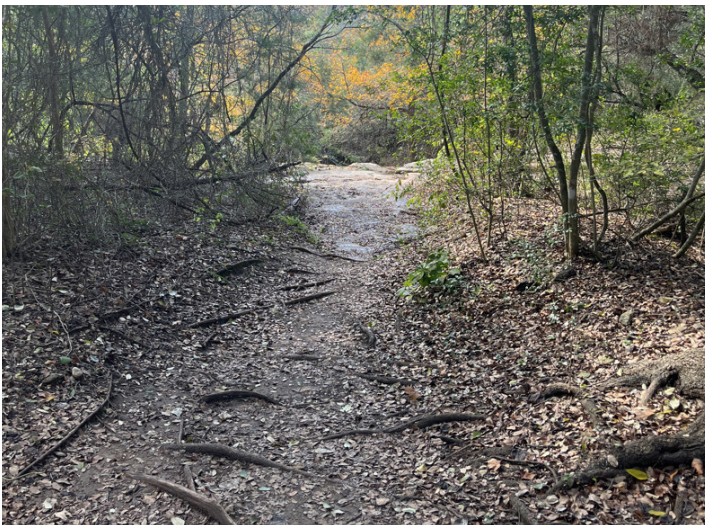
RILL EROSION near Gaines Creek Trailhead.

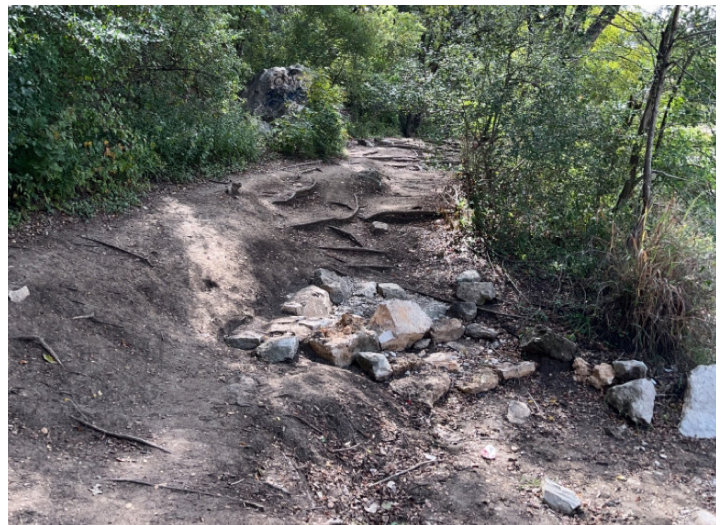
BANK EROSION near Gaines Creek Trailhead.

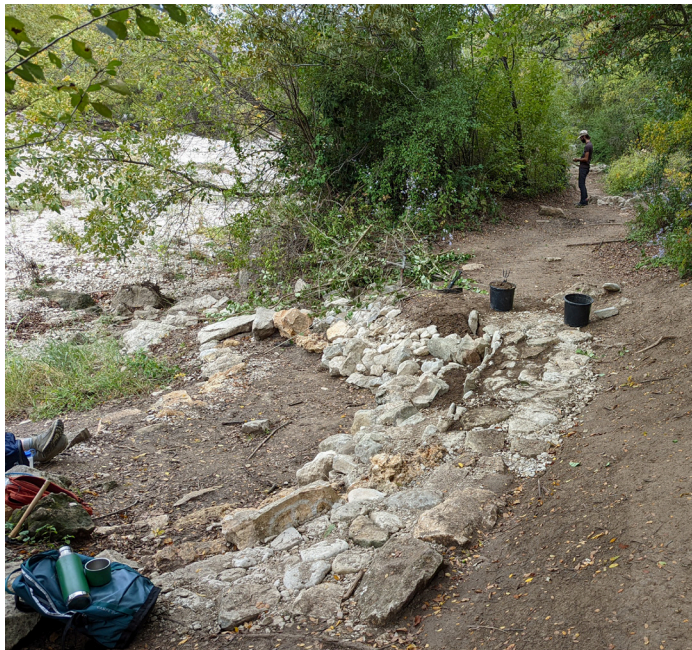
Eroded banks
near Gaines Creek Trailhead has been armored using limestone boulders sourced nearby. ▶

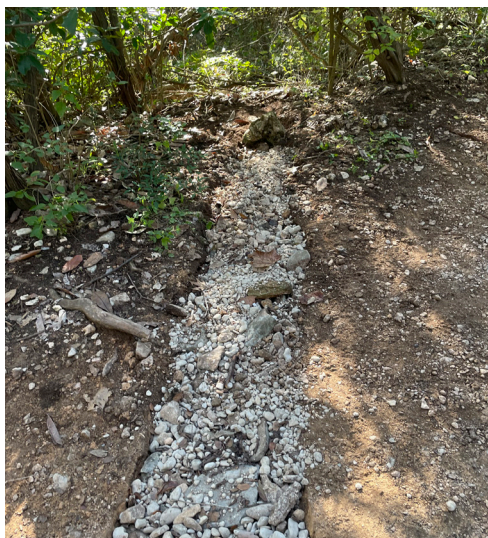
Grade dips back filled with gravel installed to mitigate sheet and rill erosion frequently occurring in low areas on trail. ▶

In these situations, the trails are restored by installing gravel backfilled grade dips to help direct the water off the trail and down the slope.

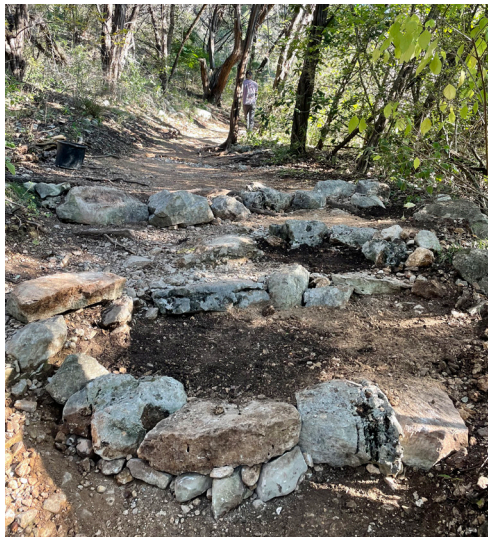
A section of trail that was eroded near the Gaines Creek Trail Head was built back up using local rocks and soil from excavated erosion control trenches. ▶

Throughout the Barton Creek Greenbelt, trail erosion has led to many exposed roots. These are a tripping hazard, and both foot and bicycle traffic cause further damage to these roots and the associated trees. To protect exposed roots and provide stability in these washout areas, boulders sourced from the Greenbelt and the soil that was removed when installing grade dips were used to build up the trail where erosion was evident. Drainage trenches to direct water off of the trail have been installed above the areas where the trail was built back up to prevent washouts from occurring in these areas in the future. Another example of trail armoring includes the formalization of water access points that were contributing to erosion along Barton Creek. In these situations, large, flat rocks were used to create a safe, accessible walkway for trail users to utilize that would limit further erosion.

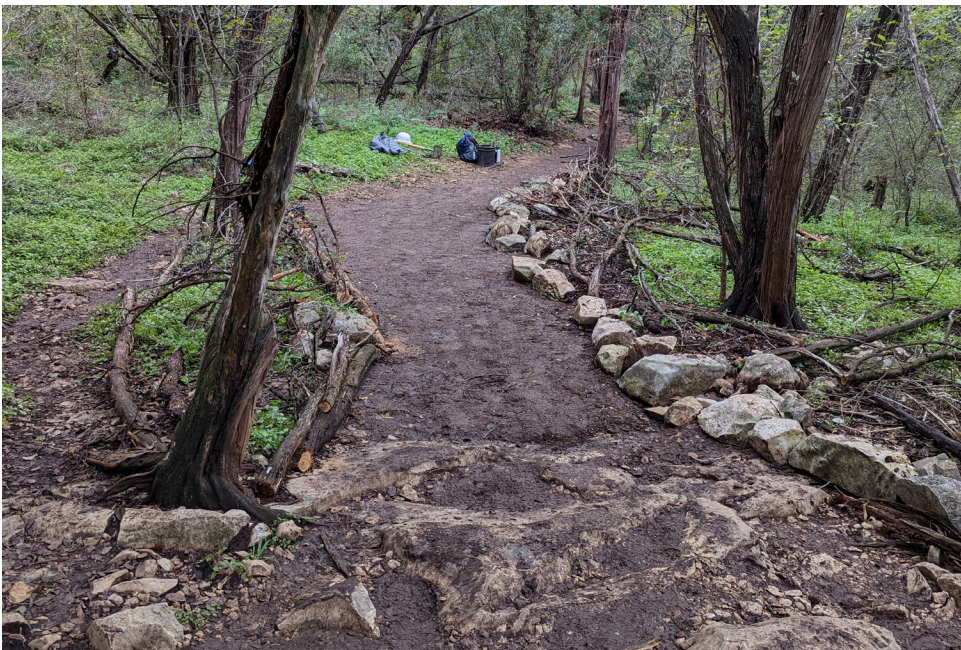
Rocks and brush used to delineate a more narrow path in a wide segment of trail. Edges were seeded with inland sea oats ▼

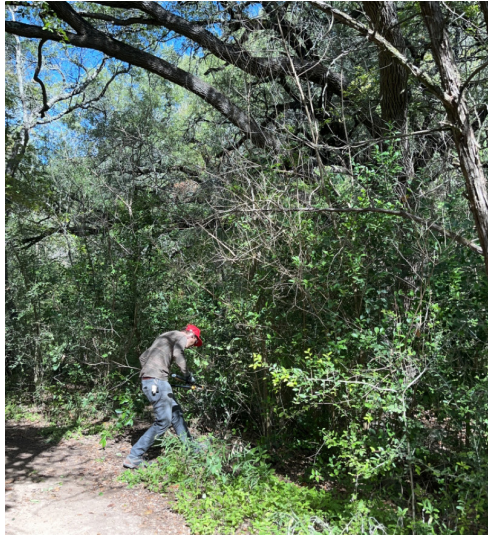
A patch of ligustrum near the Gaines Creek Access Trailhead. ▶

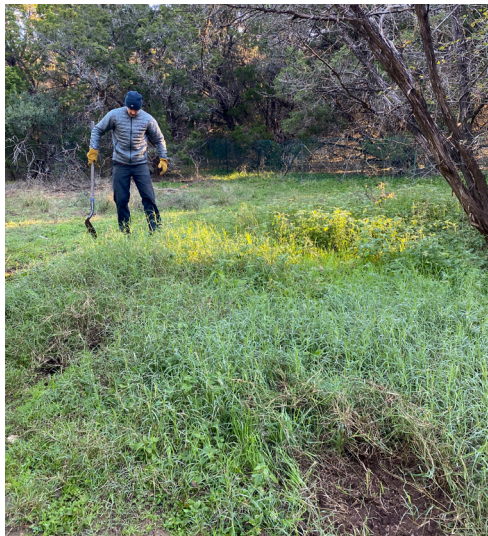
A patch of Bermudagrass at the Gaines Creek trailhead before removal. ▶

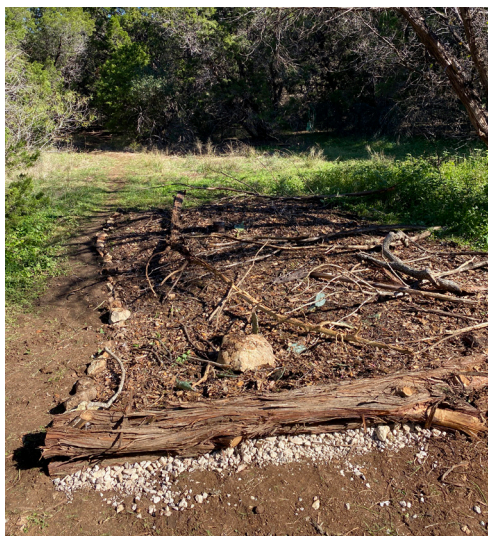
The same area as the photo above following invasive removal. The area has also been seeded and brushed to prevent trampling. ▶

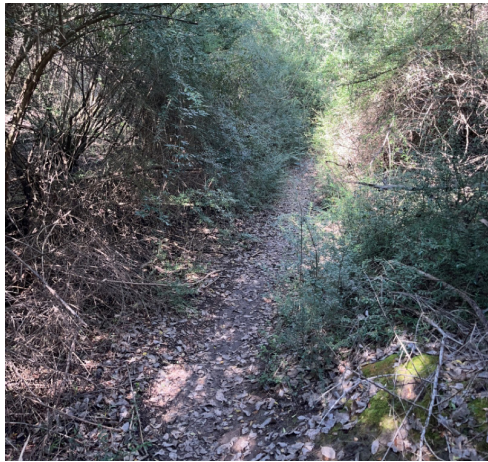
Creekside trails southwest of Barton Creek between Sculpture Falls and the Hill of Life dam have been significantly narrowed by invasive privets. Efforts have been made for the mechanical removal of seedlings and saplings. Further treatments with herbicide application are needed for larger shrubs and trees at these locations to clear up the trail for users and reduce invasive populations.

Overgrowth of privet on the southwest creekside trail between Sculpture Falls and Hill of Life trail. ▶

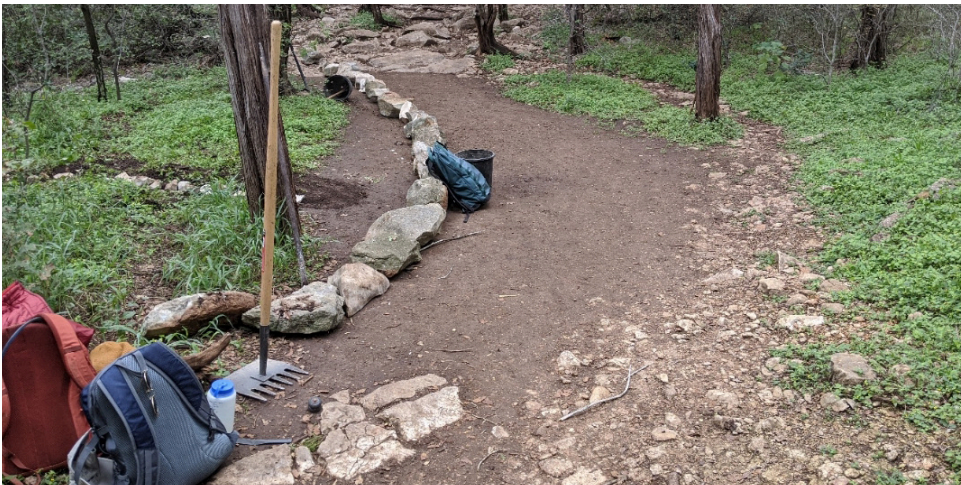
Rocks used to delineate a more narrow path in a wide segment of the trail. ▼

To address wide trails, providing drainage is generally required to resolve the main issues of mud or ponding water. Rocks or logs are placed to obtain a desired trail width. Compacted soil in the retired areas is tilled and native seeds are planted to encourage regrowth. Seeded areas are then brushed to avoid further foot traffic, protect the establishment of new growth, and contribute organic matter to the soil.

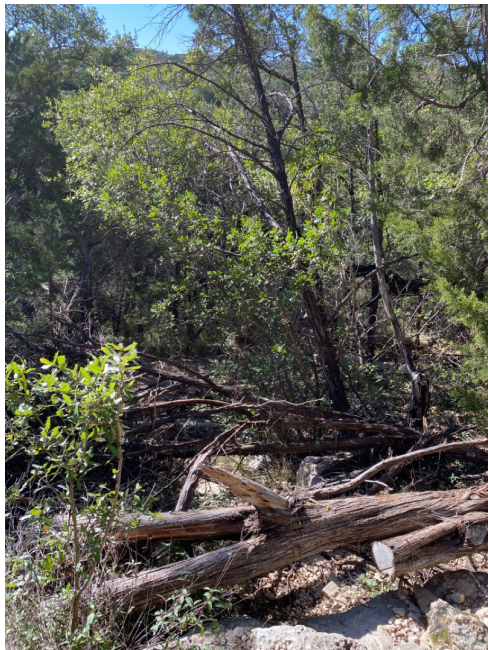
A brushed informal water access point. ▶

To stop future foot traffic on informal trails, these trails are blocked with large rocks or brushed with logs and fallen branches. Retiring these trails will reduce the erosion associated with these trails and will allow native plant species to repopulate.

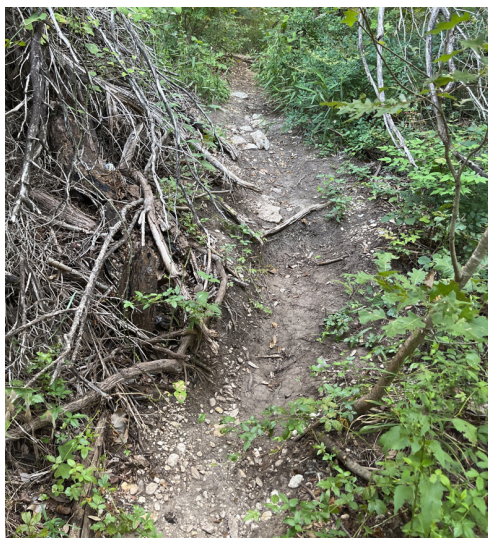
An informal trail with signs of erosion. ▶

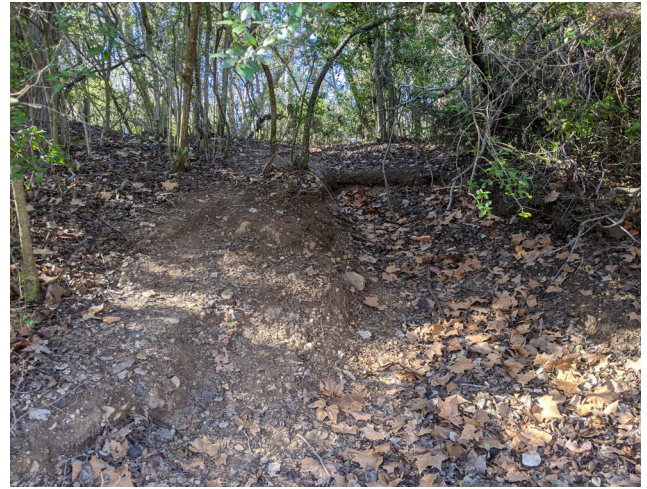
The Hill of Life dam is a popular area on the Barton Creek Greenbelt where visitors enjoy various water-based recreational activities. While this is a frequently visited location, there are currently no formalized water access trails or steps. Instead, access points south of the dam are steep informal trails that are slick when wet, and have in several areas developed sheet, rill, and gully erosion.

▲ *Currently, the trails south of Hill of Life dam are steep and eroding. Installing steps on these trails can help prevent additional erosion and provide visitors with better access to this high use area of the Barton Creek Greenbelt.*

A potential future project for Siglo Group involves installing steps down to the Hill of Life dam to formalize access to the water and to address large sections of sheet erosion along the trail. Steps will be created using cedar logs set in place with rebar. To address current erosion issues and prevent future erosion, water will be redirected off of the steps into drainage areas. These steps will provide visitors with a safe path to and from the dam and discourage utilization and creation of informal trails. Following the construction of the stairs, non-designated trails in the area can be retired to promote regrowth of native vegetation and reduce soil erosion and compaction.
